Pre-Restoration

13-01-78-13 W6 Bridge Installation

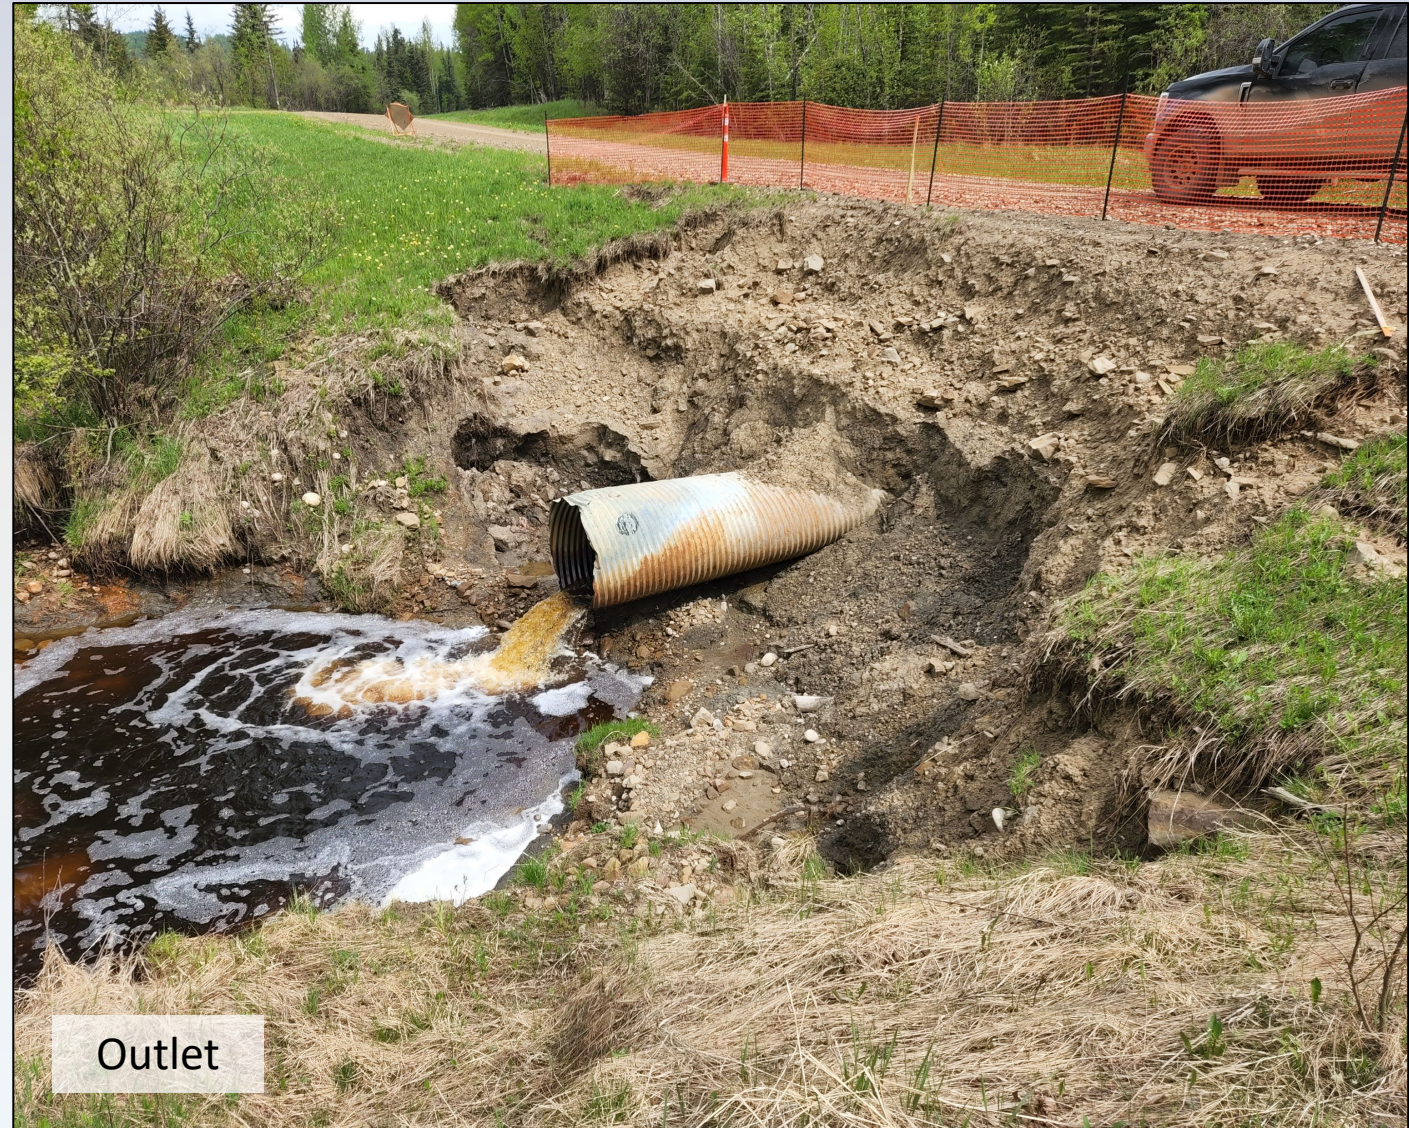
Outlet

Hanging culvert, undersized (1200mm)
High-unsatisfactory erosion and
sedimentation

Hanging and undersized culvert replaced with a 60' bridge.

Silt fencing, grass seeding and willow staking implemented

Channel rebuilt to match upstream natural

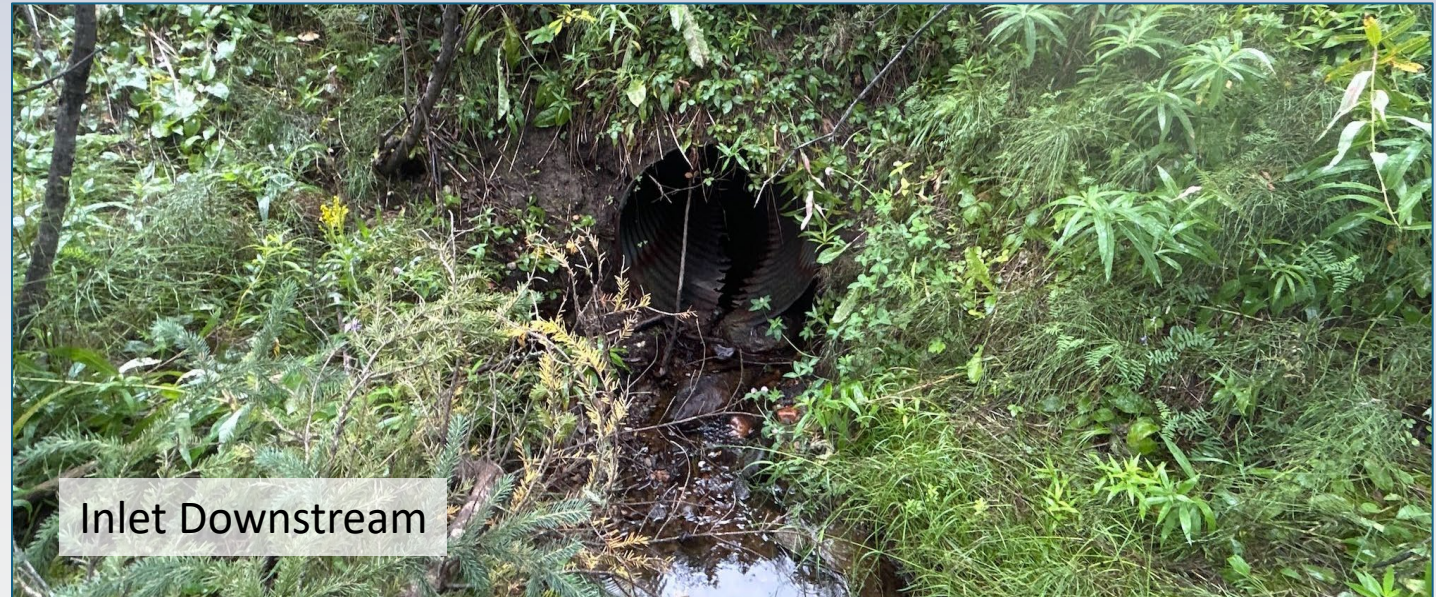
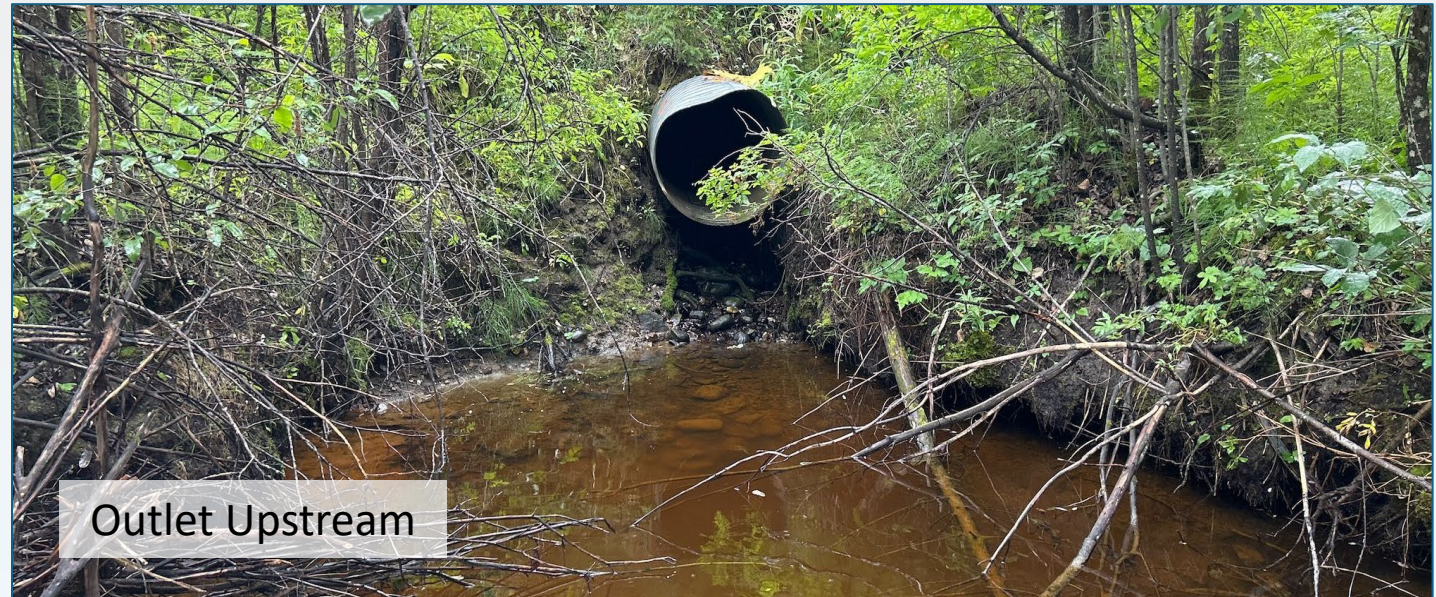
Hanging and undersized (800 mm) culvert

High-unsatisfactory erosion and sedimentation due to hanging outlet

Undersized hanging culvert replaced
with 2000 mm open-bottom arch

Willow staking, native grass seeding
and silt fencing implemented

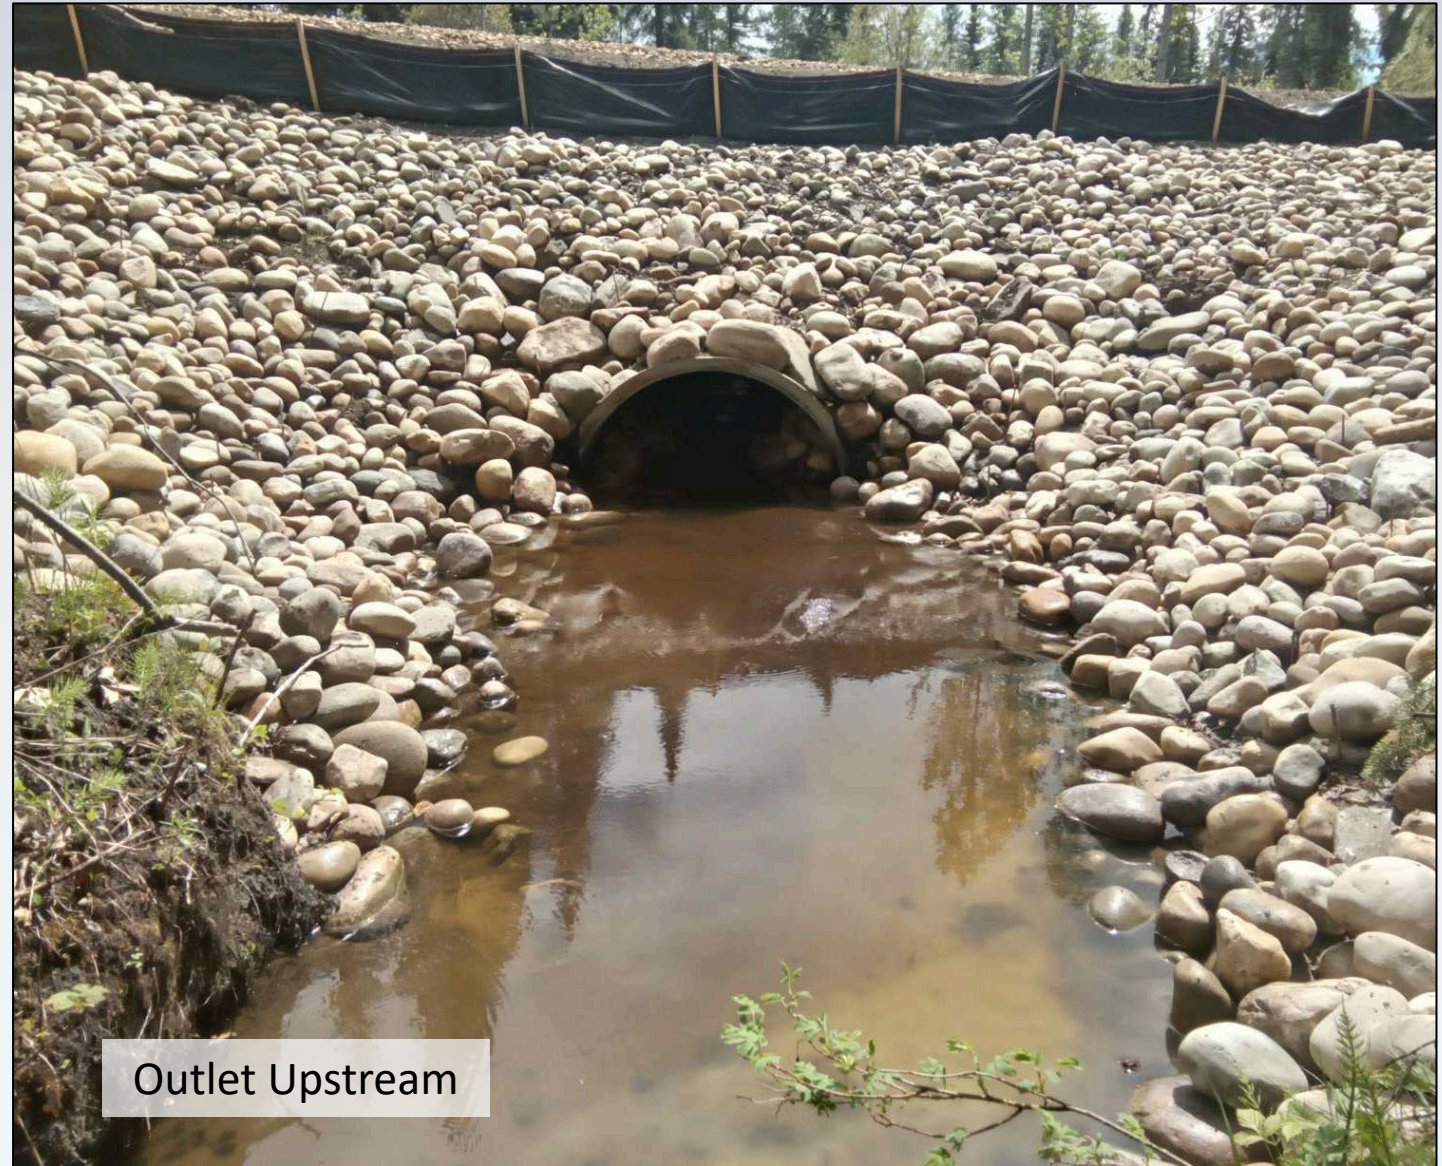
Outlet Upstream

Multiple crushed and undersized (1100 mm & 800 mm) culverts

High-unsatisfactory erosion and sedimentation

Culverts replaced with a 10 m x 3000 mm open-bottom low-profile arch.

Structure is rated for L140 with engineered reinforcements

Channel rebuilt to match upstream natural

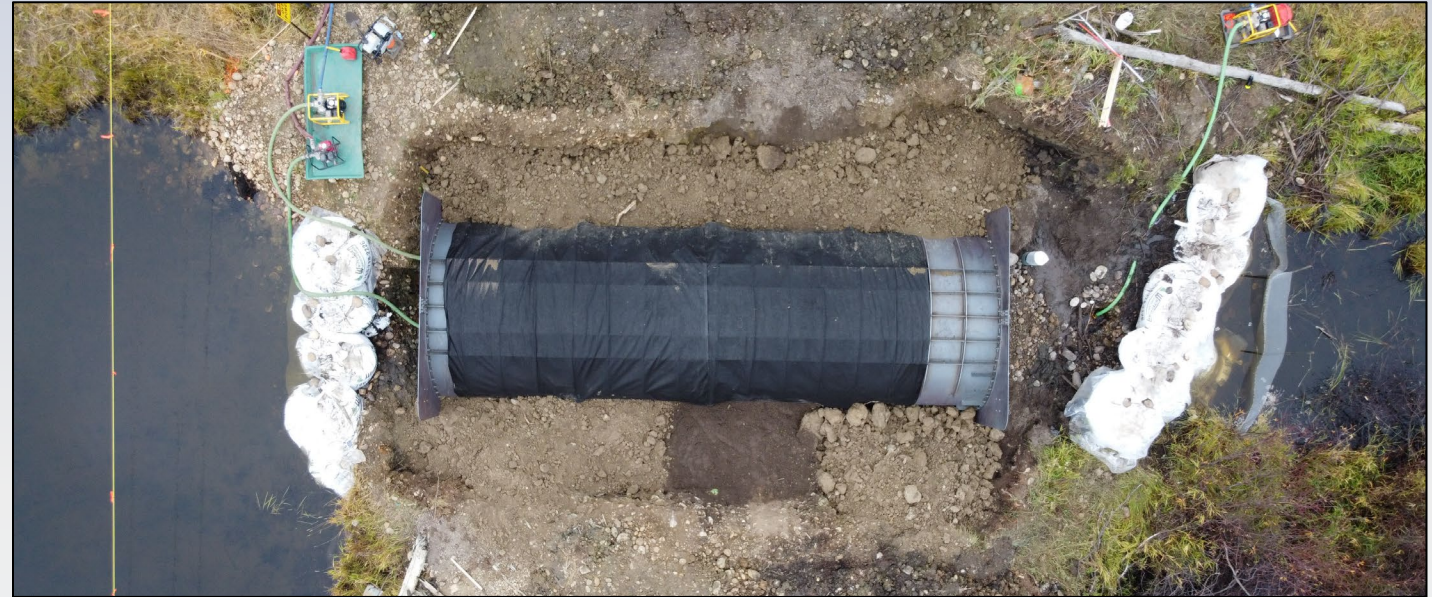
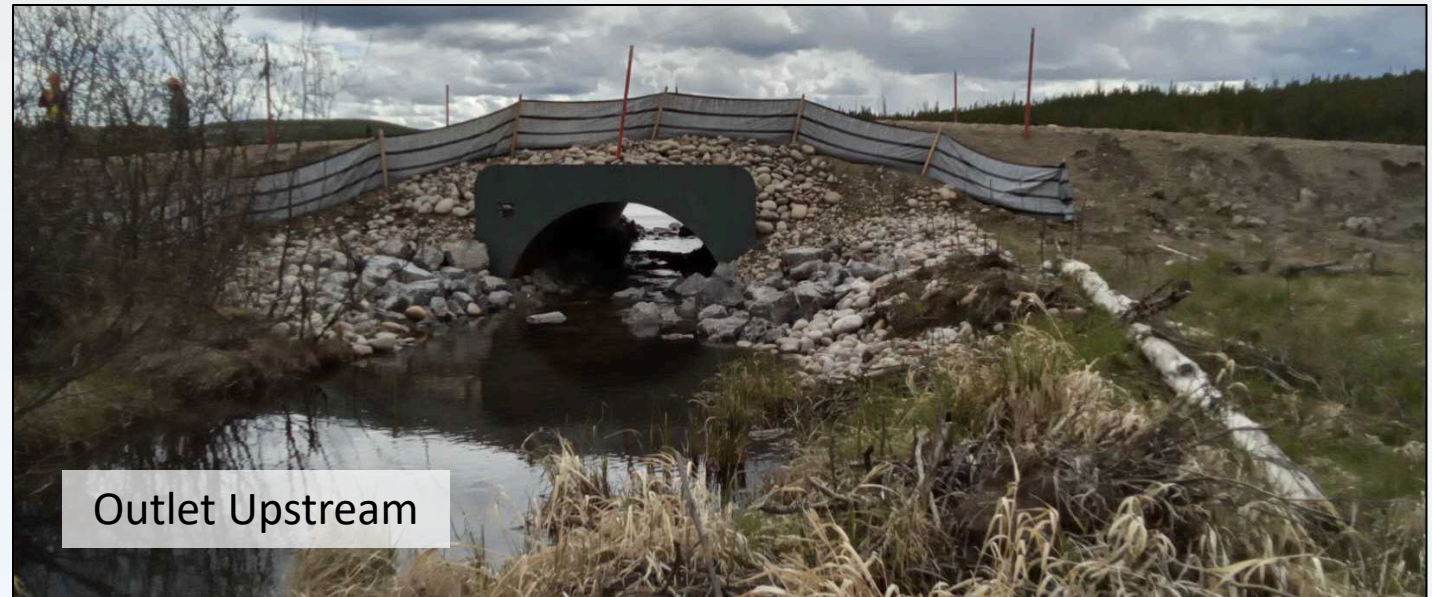
Outlet Upstream

Undersized (1200 mm x 12 m) and
hanging culvert

Structurally damaged

Erosion and sedimentation

Culvert replaced with 3500 mm x 13 m open-bottom low-profile arch.

Channel rebuilt to match upstream natural

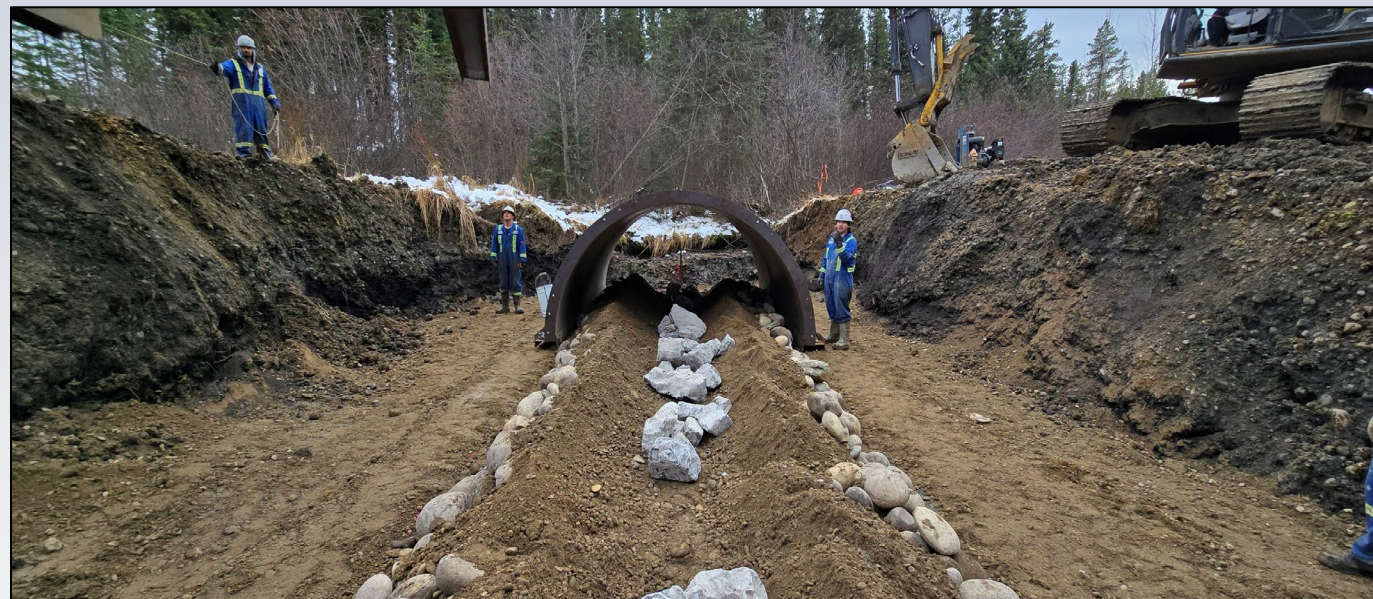
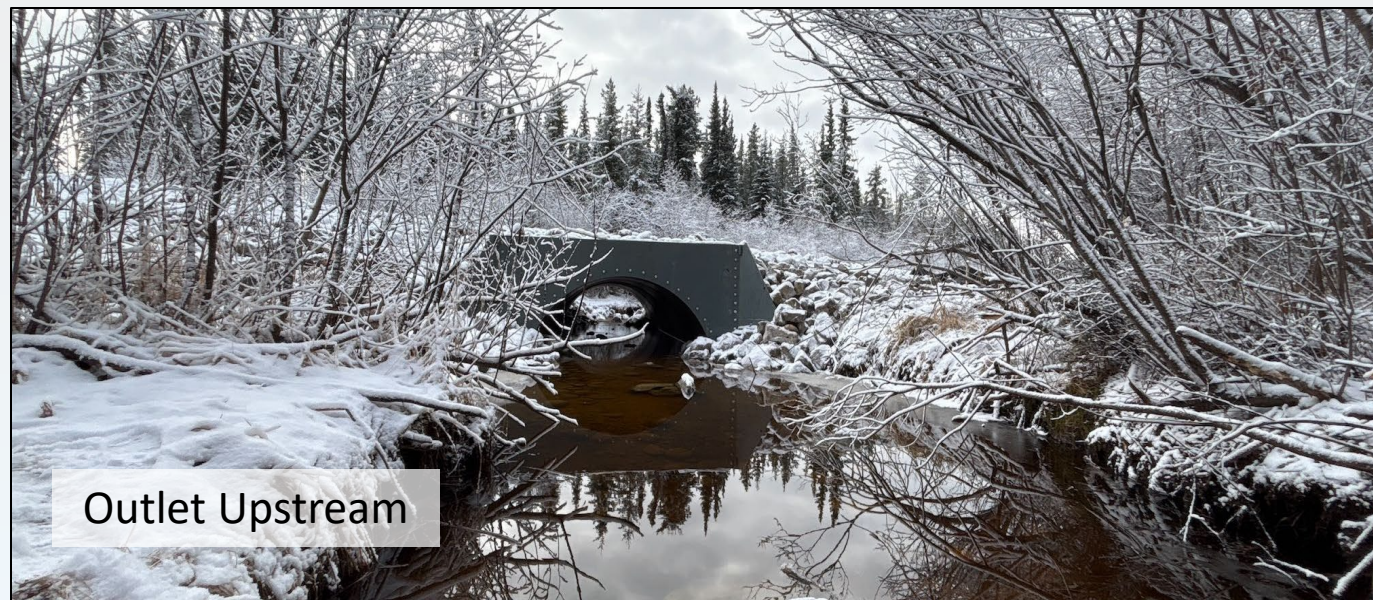
Outlet Upstream

Multiple hanging and undersized culverts
(1200 mm x 21 m)

High-unsatisfactory erosion and
sedimentation from hanging culverts

Channel running along ditch for 30 m

Culverts replaced with a 30' bridge

Channel redirected out of the ditch and rebuilt approximately 75 m. 30' Culverts removed and replaced with a 30' bridge

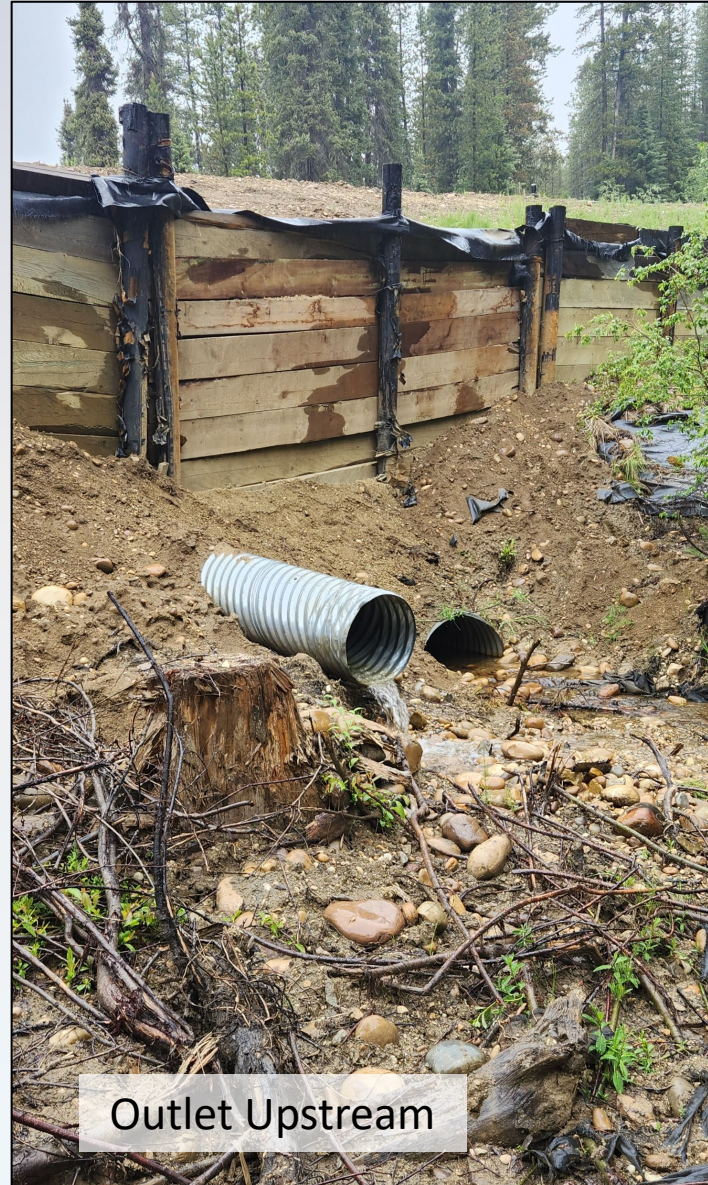
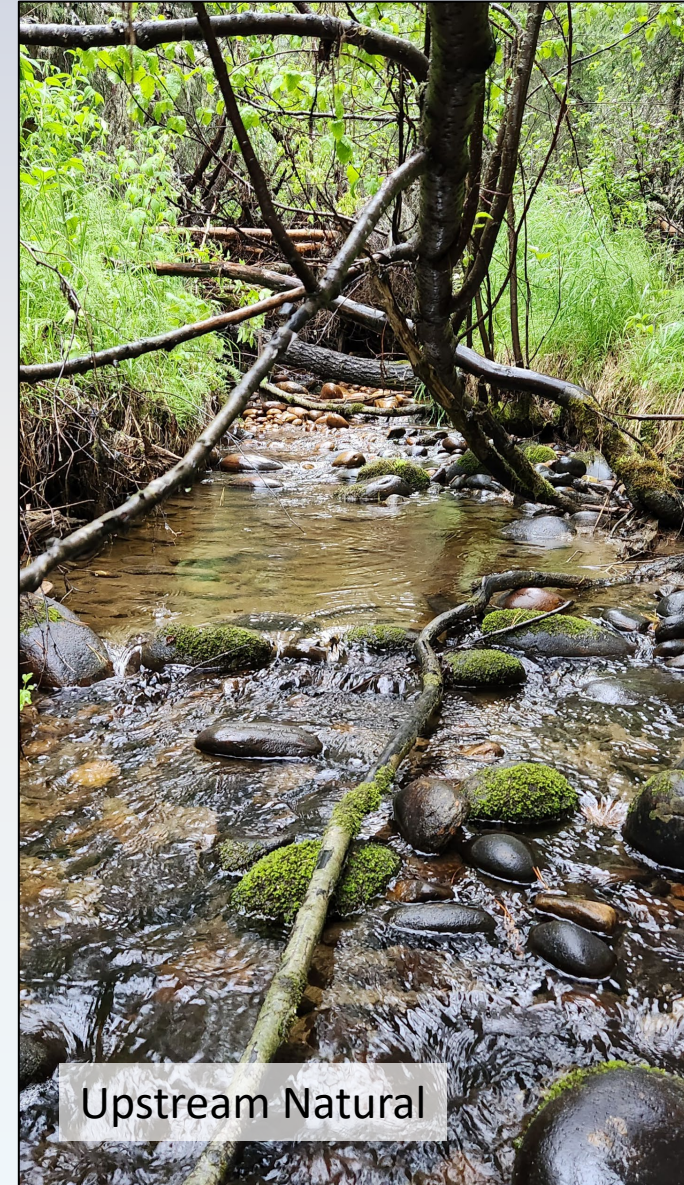
Undersized hanging, embedded and blocked culverts (800 mm & 500 mm)

High-unsatisfactory erosion and sedimentation

NOTE: Failed crossing is only 11 years old

Culverts replaced with 60' bridge on steel pilings.

Silt fencing, and native grass seed implemented. Willow staking will occur in spring 2025

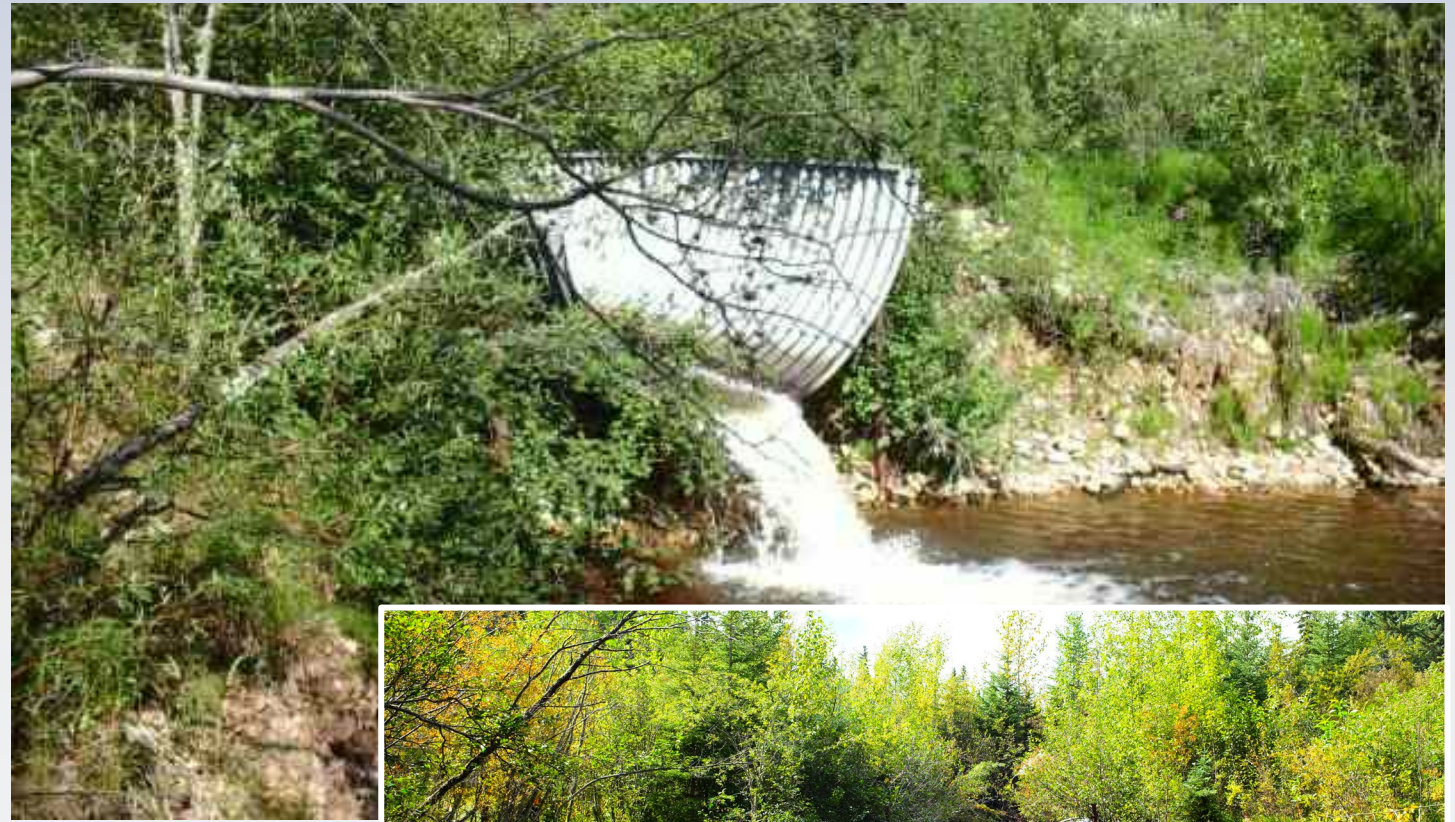
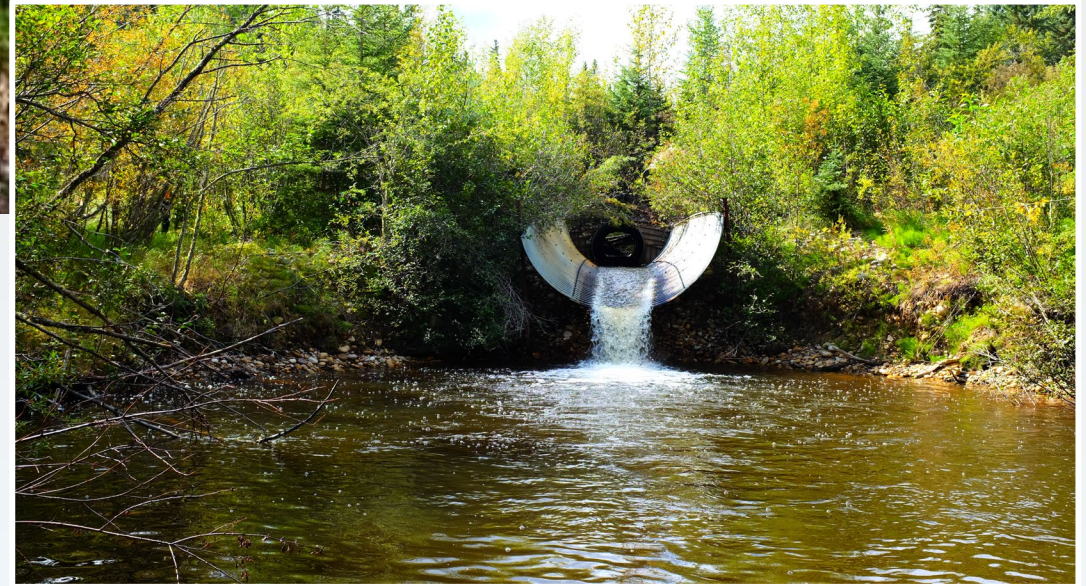
Outlet Upstream

A historic flume installed by Alberta Government in the 70's was the initial barrier on this tributary to the Swan River. The road accessed 2 wells that were near end of life.

This is one of four barriers removed on this drainage to restore access to almost 23km of Grayling habitat.

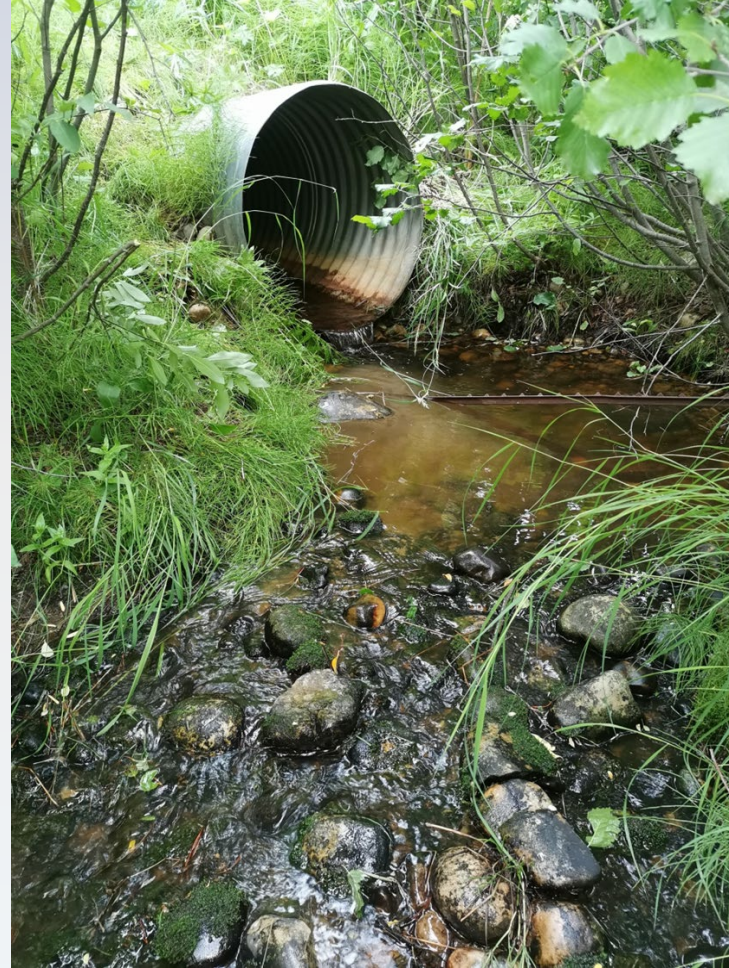
Outlet Upstream

Installed a one-piece Type II open bottomed arch on a failed undersized culvert.

Arch structure is set in place on concrete loc-bloc foundation.

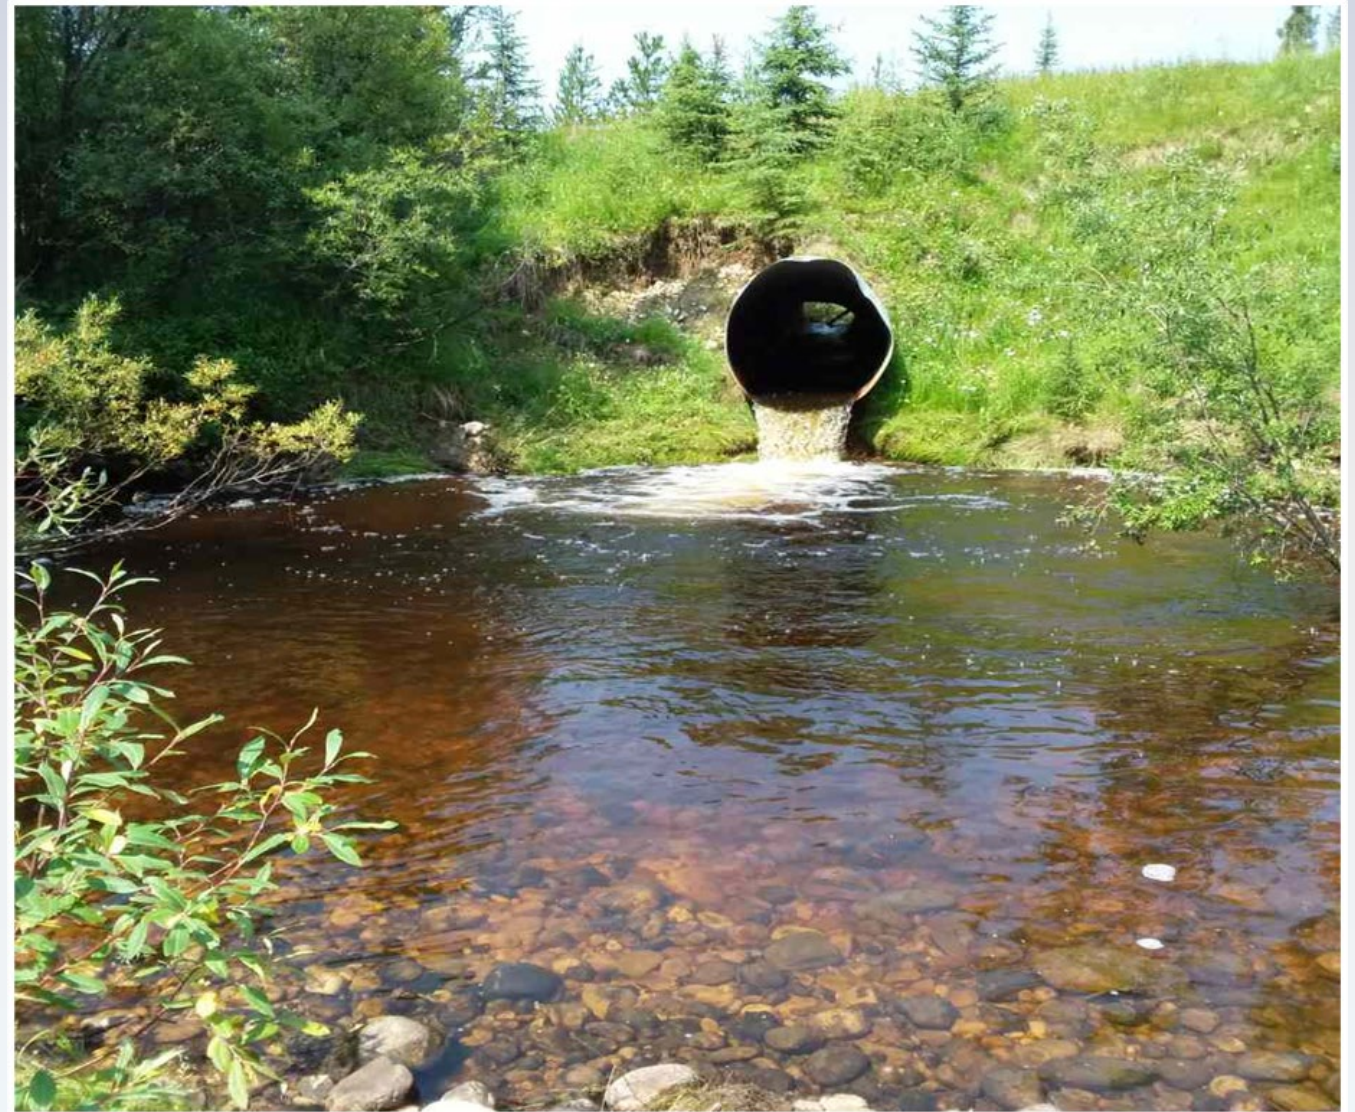
Outlet Upstream

Historical road no longer used by disposition owner was reclaimed along with 4 crossings. This is the largest of the four and has been in place for over 25 years

Complete removal of the road and fill and creation of a new stream channel. New riparian area is planted with conifer and deciduous stems and staked with willows.
