### Town of Grande Cache

#### Source Water Protection Plan: Victor Lake and Grande Cache Lake

**March 2015**

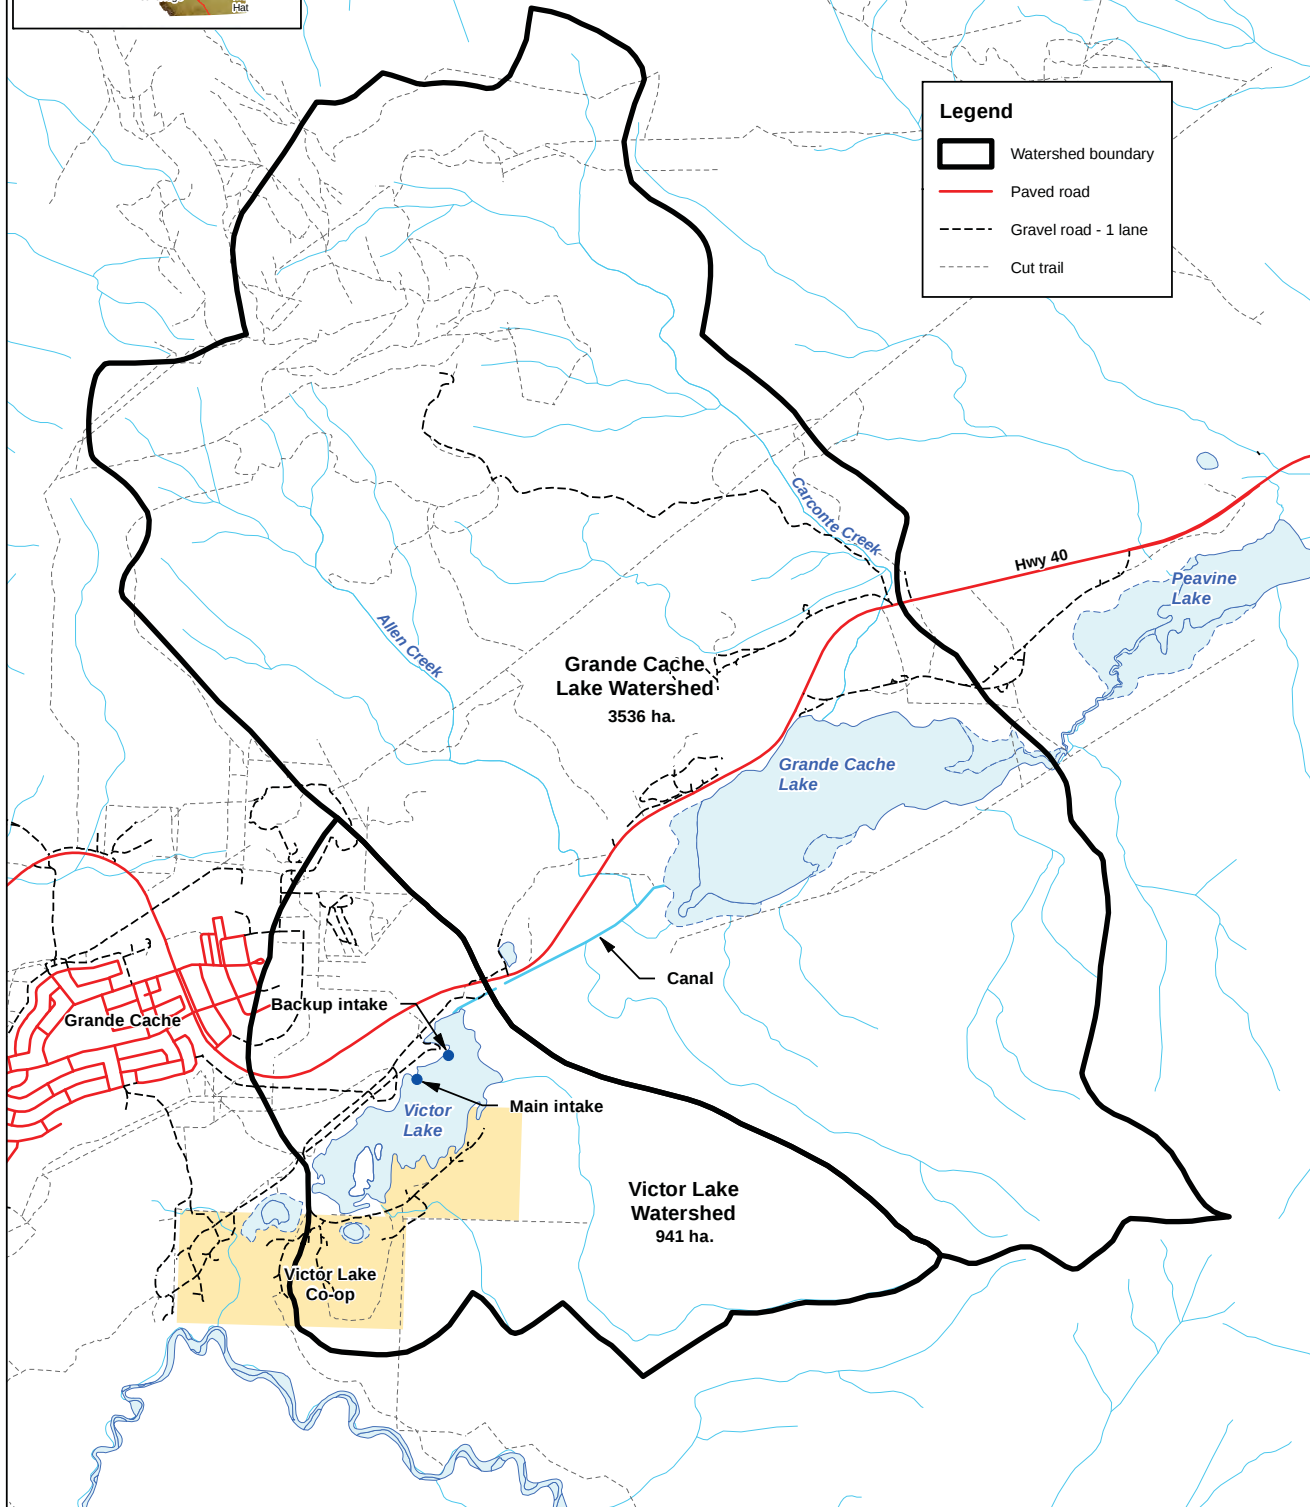
The area addressed by the SWPP is the watersheds draining to Victor and Grande Cache Lakes (Figure 1-1 and Map 1 (attached in Appendix B; henceforth "the plan area"). As noted above, the predominant flow direction between the lakes is from Victor Lake to Grande Cache Lake. Therefore risks in the Victor Lake watershed are considered a higher priority for action (refer to Section 1.4).

There is a tributary to Carconte Creek that runs through the closed mine and drains into Grande Cache Lake from the southeast (Figure 1-1); therefore potential exists for the transfer of contaminants from the garbage that is being disposed of at the site. Contaminants from that mine site could potentially travel into Grande Cache Lake via groundwater infiltration.

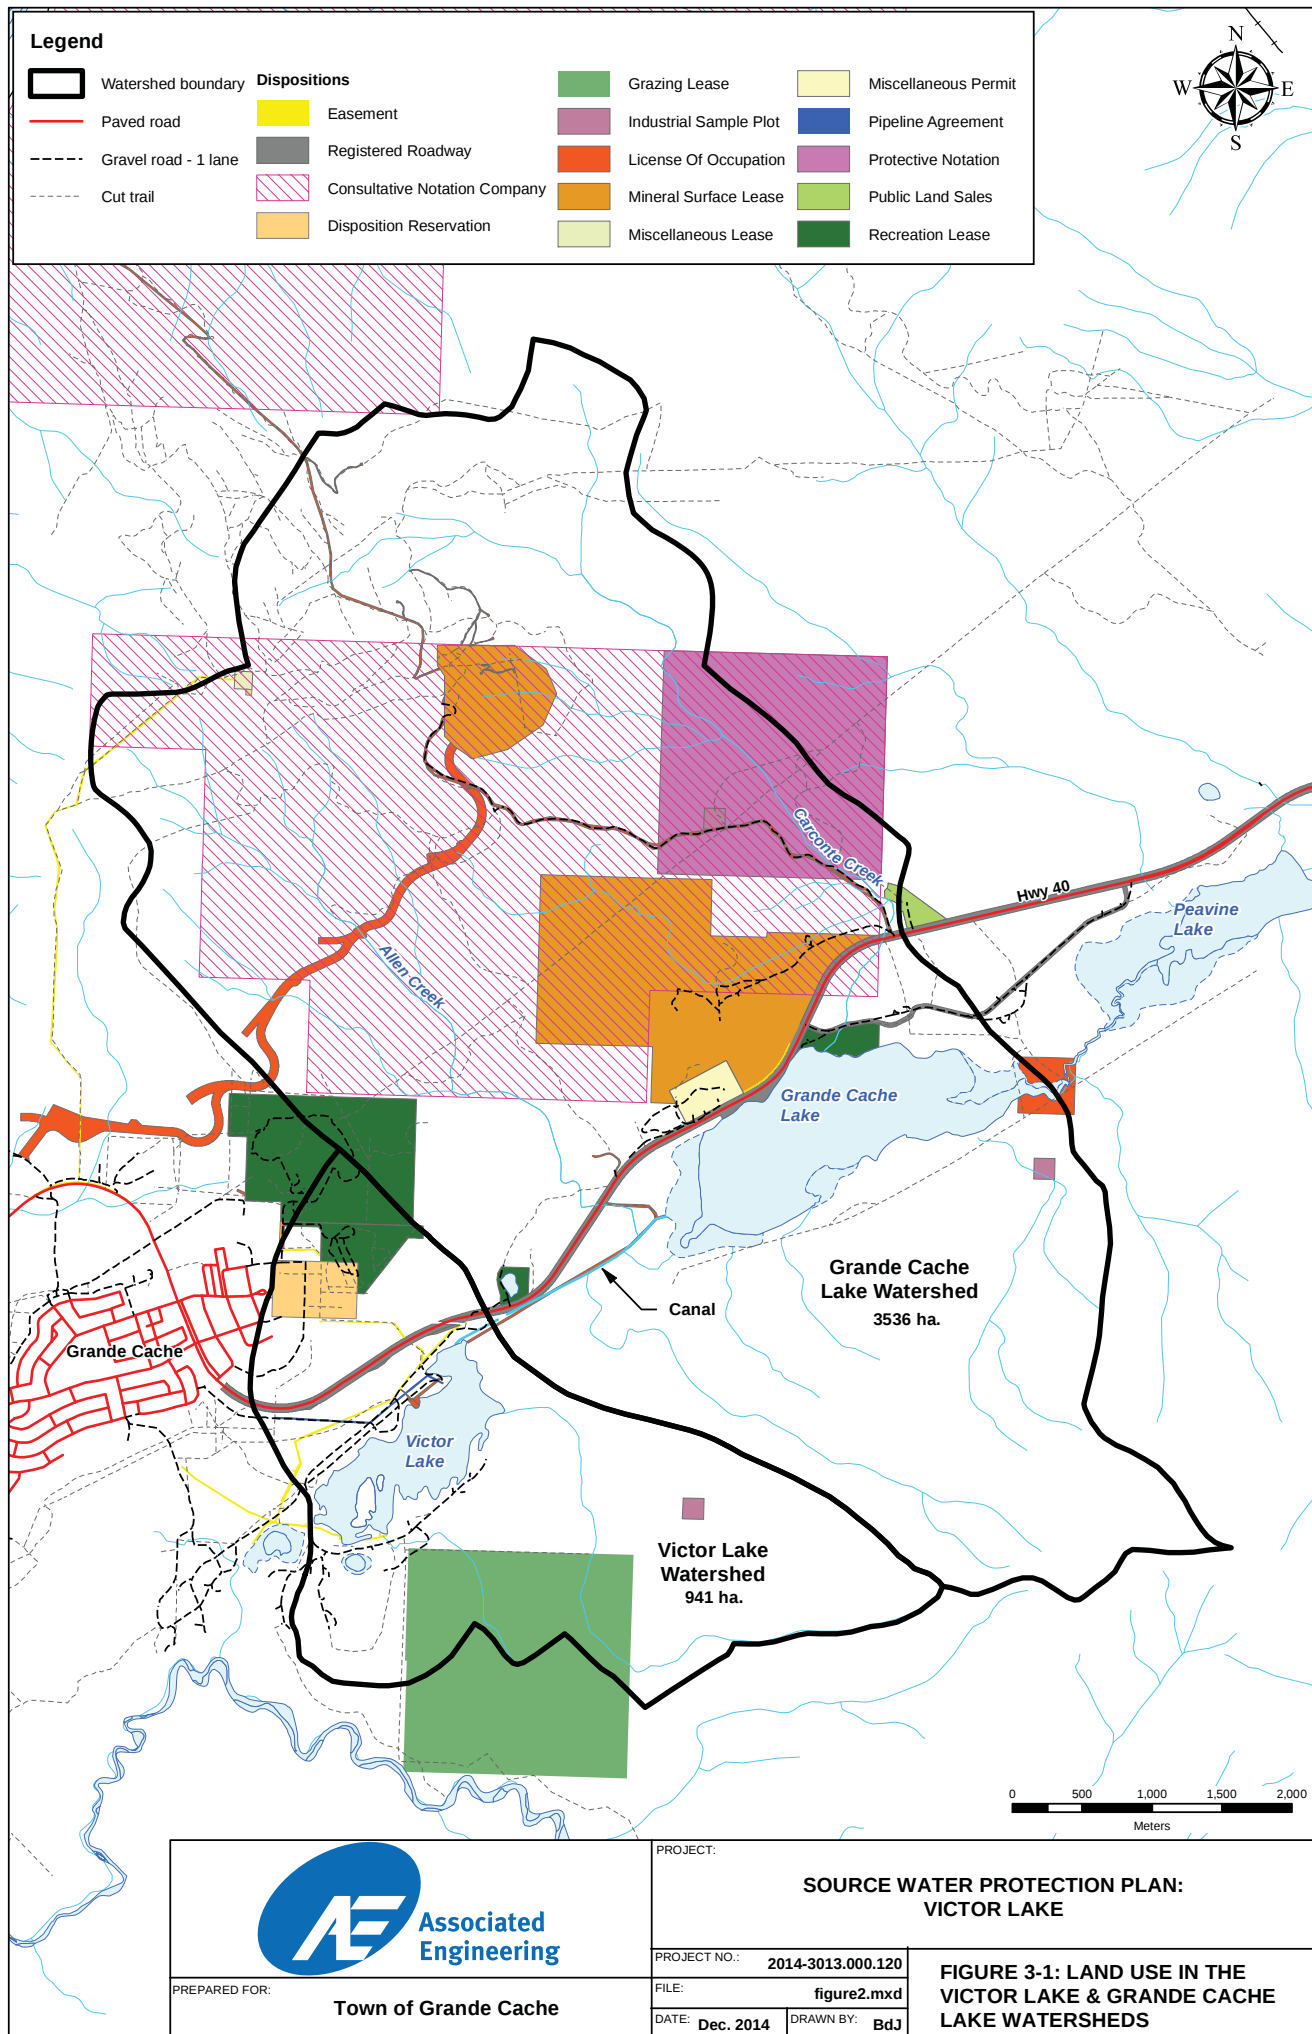
Highway 40 (Hwy 40), which is maintained by Alberta Transportation, is a major paved highway located in the Grande Cache Lake and Victor Lake watersheds. As can be seen from Figure 3-1, there are a number of secondary resource roads in the plan area that have been built and are maintained by the mining and forestry companies operating within both watersheds.

Runoff also reportedly accumulates during heavy rainfall and freshet within the old gravel pit area that is located on the Victor Lake Metis Co-op (Figure 3-1 and Map 1). The gravel pit was formerly operated by the railway company and it not known whether industrial activities other than gravel extraction occurred there. Water readily infiltrates to the ground given the gravelly soil and has the potential to reach Victor Lake via subsurface flow. However, the gravel pit is located approximately 650 m from the shores of Victor Lake so the infiltration of runoff to ground in the pit is unlikely to have a measureable effect on water quality at the Victor Lake intake.

An old mine reportedly operated by Smoky River Coal Ltd. is located approximately 500 m to the northwest of the shore from Grande Cache Lake (Figure 3-1). Although road access to the mine from Hwy 40 has been blocked off at the entry by large boulders, some residents are using the area to dispose of garbage. Old oil drums, mattresses, and other types of waste were observed at the base of the slope below the pit during the field reconnaissance visit on August 13, 2014. The garbage has been thrown over the waste rock slope in the direction of Grande Cache Lake. The mine has not been reclaimed, and the pit remains open with exposed slopes. However, there was no evidence of drainage leading away from the pit towards the lake, and there was no standing water in the pit. Some potential for sedimentation also exists from the exposed waste rock slopes that are located within 500 m of Grande Cache Lake.

The hazard relates to the potential for effects on raw water quality from forestry activities in the area. As can be seen from Figure 3-1, there are currently no forestry dispositions within the Victor Lake watershed. There is, however, a Consultative Notation (Company) for forestry activities located within the Grande Cache Lake watershed. The disposition is held by Foothills Forestry and occupies about 30% of the Grande Cache Lake watershed. At its closest point, the Foothill's disposition is about 500 m to the shores of Grande Cache Lake.
