Pre-Restoration

13-01-78-13 W6 Bridge Installation

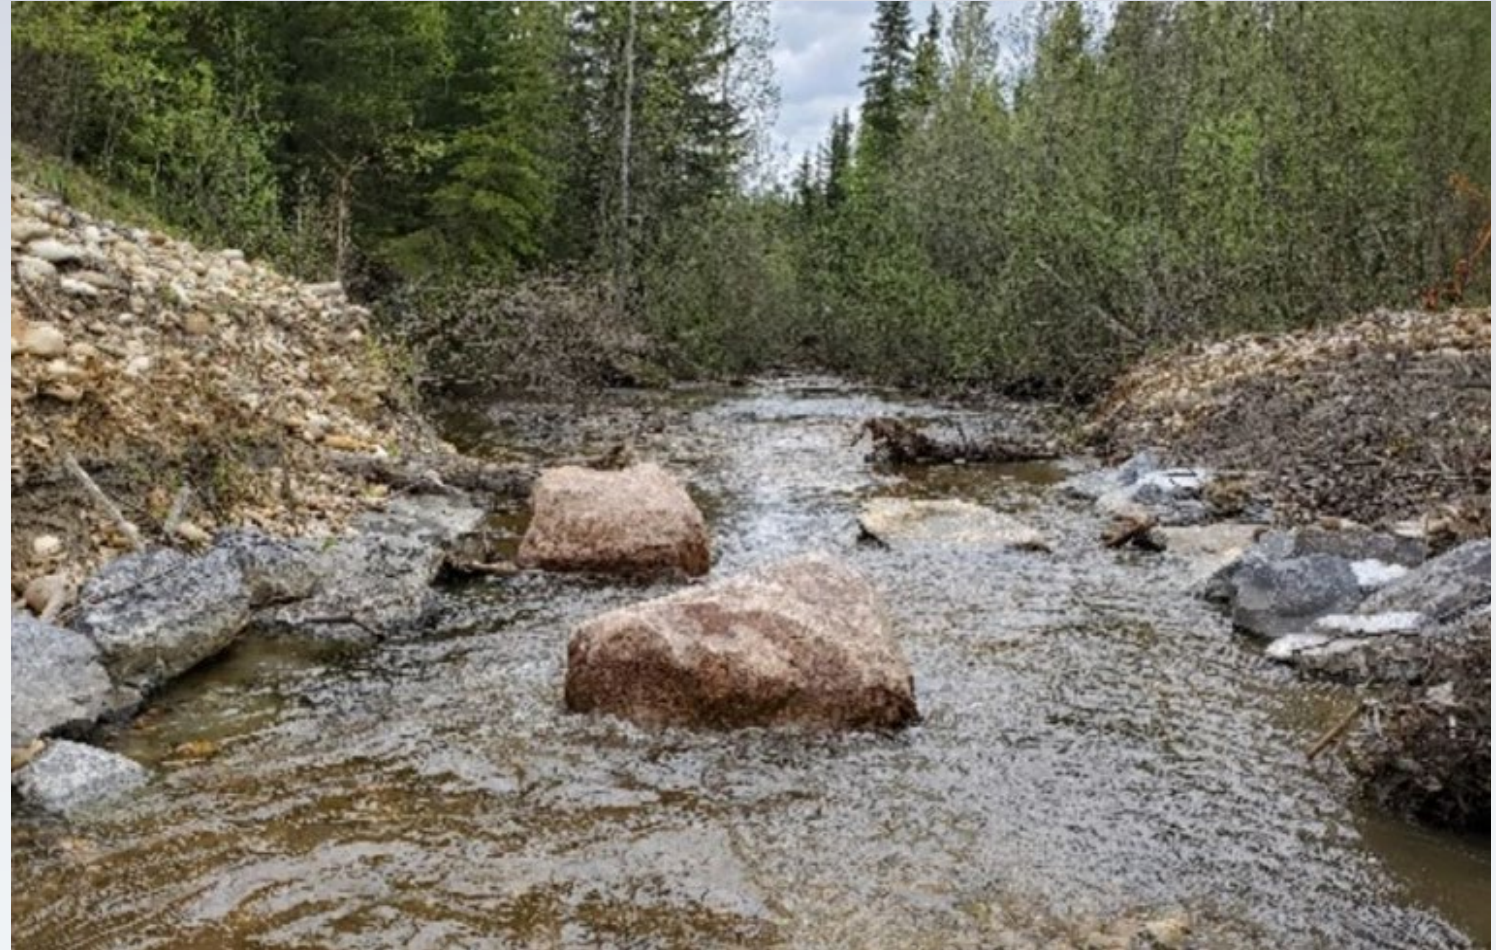
12-15-67-10 W5 (1) Removal and Restoration

This is one of four barriers removed on this drainage to restore access to almost 23km of Grayling habitat.

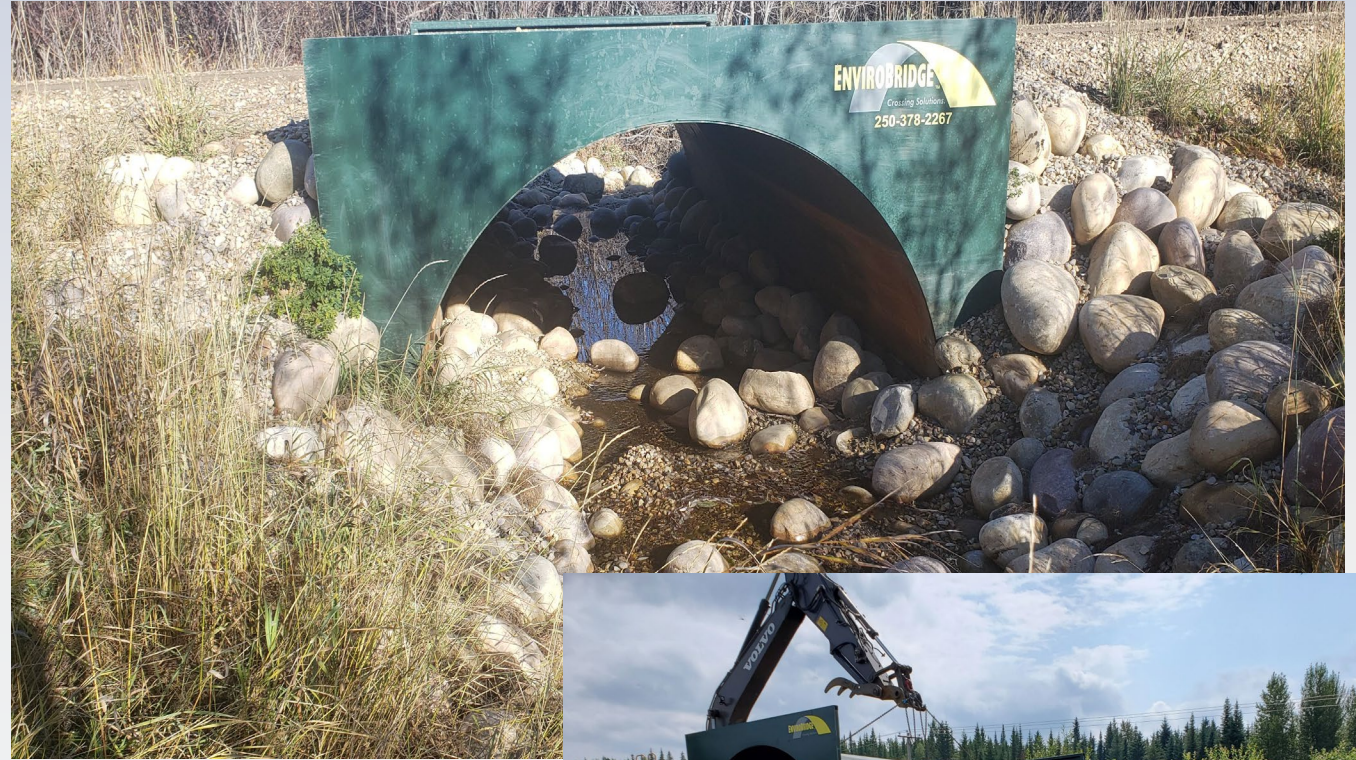
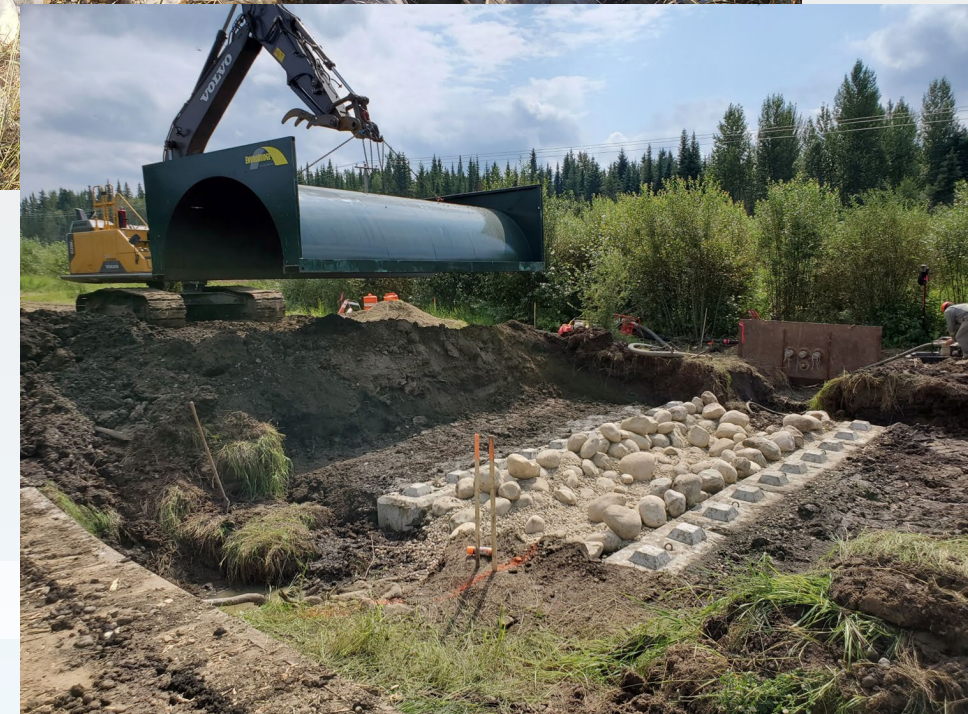
14-9-67-10 W5 (1) Removal and Restoration

High use road near facility, structure is L100 rated.
